VIBRATION ANALYSIS REPORT ON

EXHAUST BLOWER (BPP-FAE-622)

AT AUTO ALLIANCE (THAILAND) CO., LTD.

REPORT NO.: P-SWB-06-01

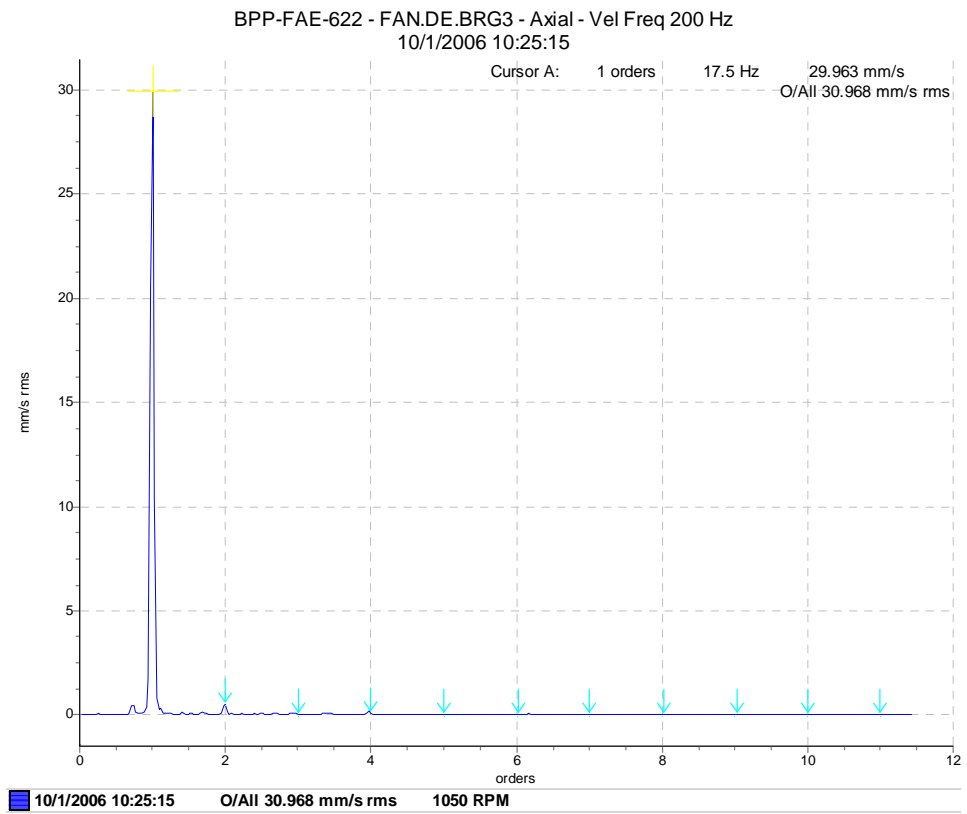
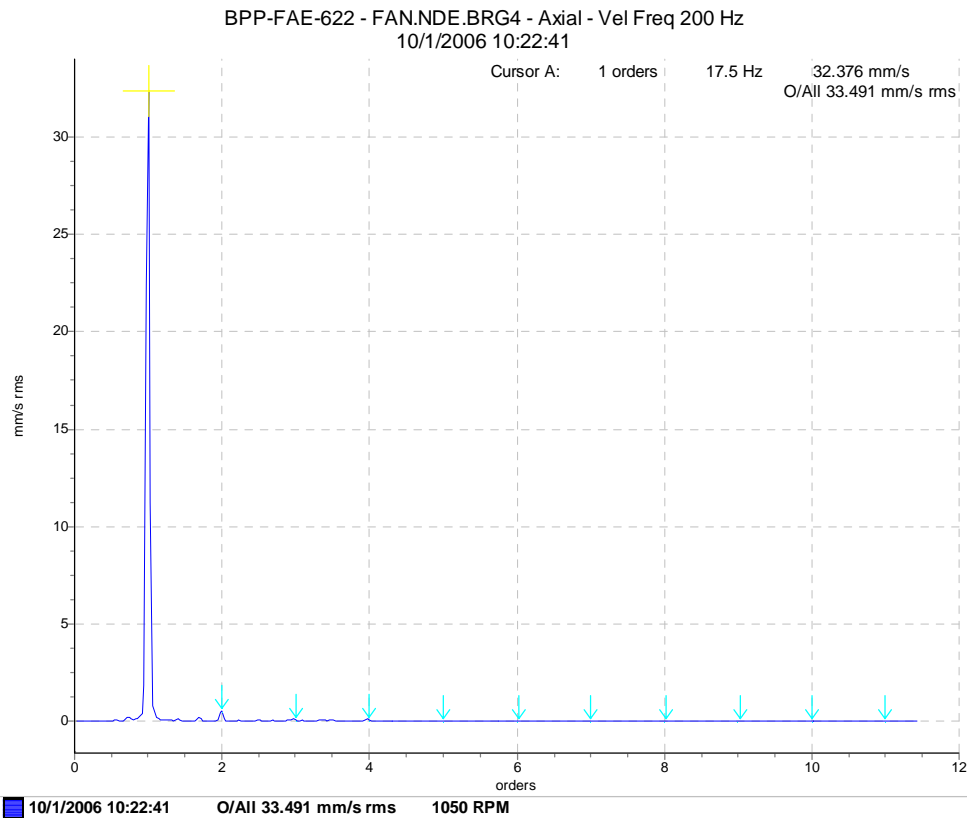
Refer to ISO 10816-3; this machine is classified in the machine group 2; flexible foundation, the machine severity is “Inadmissible” ($> 7.1 \text{ mm/s}_{\text{rms}}$ as the above data) condition.

The vibration high at 3A and 4A and they are much more than the other points as called “Directional Vibration”. Main source of these vibrations are only the synchronous speed of the fan speed 17.5 Hz (1050 rpm) as the spectrum attached figure 1. This is the effect of “Resonance” on the machine.

Fig. 1 Spectrum Signature at 3A. And 4A.

- 1) The first recommendation is solving at the excitation frequency of the fan. Recommend to speed up the fan to be 1200 rpm or slightly more than if this modification is not effect to the production process.
- 2) If the first recommendation could not be done, recommend to trial add the axial direction stiffness of the pedestal. The pedestal ribs are recommended to be added. After the stiffness adding, please confirm the new natural frequency by Bump Test again. This vibration problem will be solved if the new natural frequency is shift up to more than 22.75 Hz.
- 3) If the second recommendation is not work, adding mass to the pedestal is recommended to be done. How ever, in this solution method could be done by adjust the adding mass and try to test run till the system vibration go down. This method will shift the natural frequency of the pedestal down as the figure 3 as attachment.

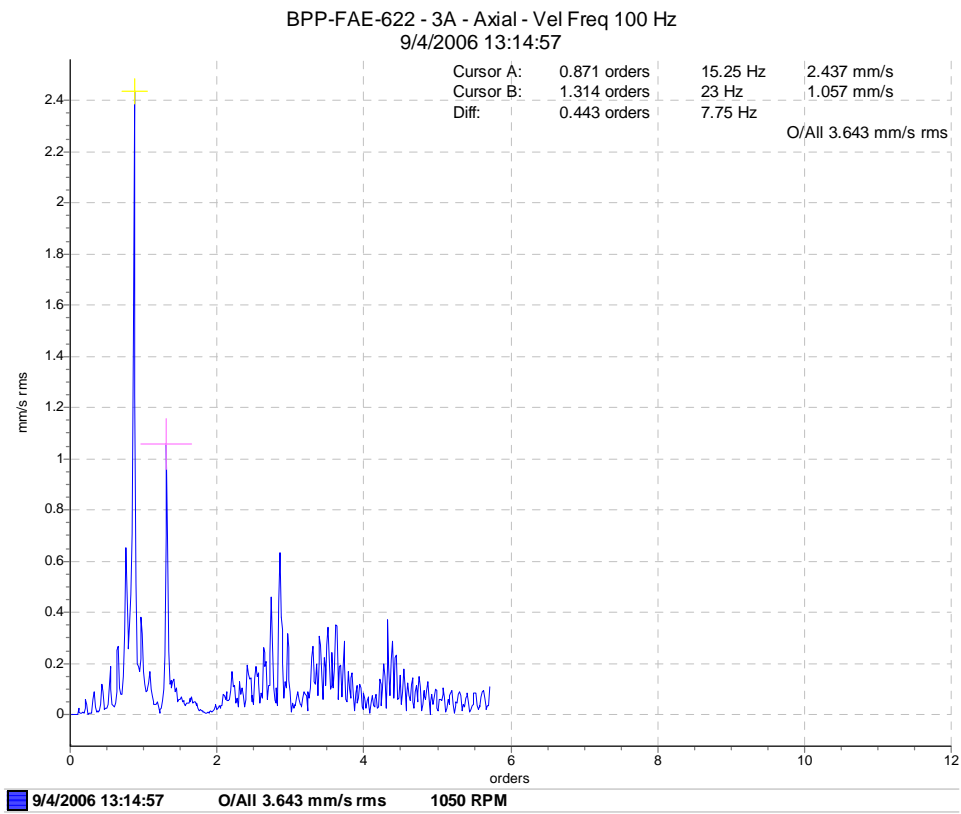
In order to confirm the Resonance Phenomenon, we have performed “Bump Test” on the machine to find out the resonant part and found that the Natural frequency of the Pedestal is 15.25 Hz as the spectrum attachment figure 2. This Natural frequency is close up the main source at 3A and 4A. The excitation force at 17.5 Hz is higher than the Natural frequency at 15.25 only 2.25 Hz or 14.75 % of the Natural frequency. So the “Bump Test” result is confirmed that this is the “Resonance Phenomenon”

Fig. 2 Spectrum Signature at 3A. as "Bump Test" at the top of Pedestal

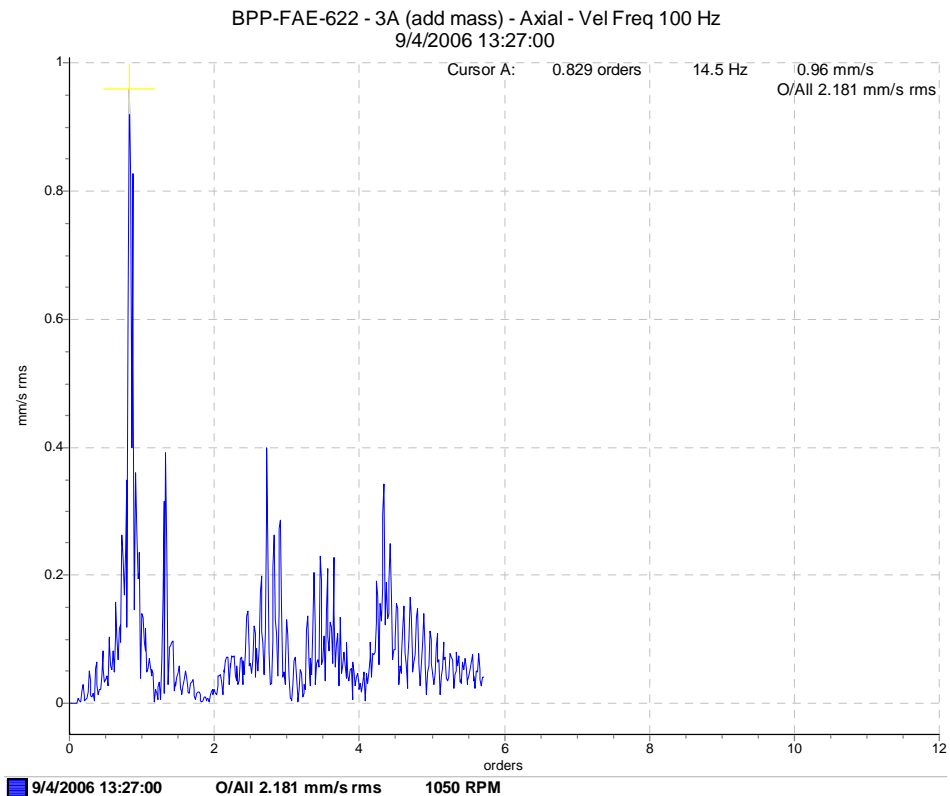
Fig. 3 Spectrum Signature at 3A. as "Bump Test" at the top of Pedestal with added mass ~100 kg. at the Pedestal
